This paper can be cited as: Coimbra, J. (2017). *Engineering Students' Perceptions of Sustainability in The Rehabilitation of Buildings: A Case Study*. PEOPLE: International Journal of Social Sciences, 3(3), 133-154.

ENGINEERING STUDENTS' PERCEPTIONS OF SUSTAINABILITY IN THE REHABILITATION OF BUILDINGS: A CASE STUDY

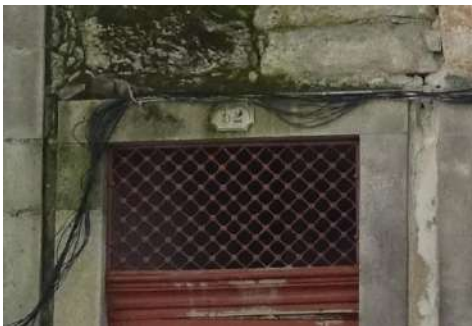
Figure 1: *Iron grid in original location above the entrance door of case study*

- Granite masonry, in order to proceed to its assembly in the new places indicated in the project;
- Roof tiles, for posterior washing and reapplication on the new roof;
- Exterior and interior hydraulic tiles, for later rehabilitation and reapplication in the areas indicated in the project;
- Iron grids of windows and external doors, for treatment and mounting in the same places, as seen in Figures 1 and 2;
- Wooden interior doors, for treatment, painting and assembly in the same places from which they were removed.

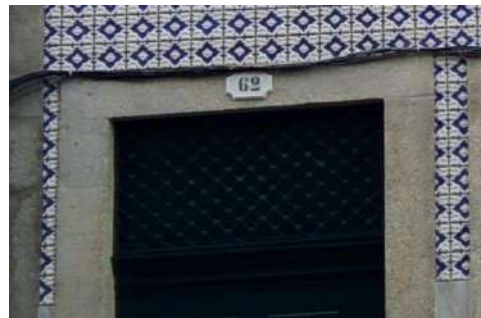
Figure 2: *The grid depicted in Figure 1 after treatment and painting of case study*

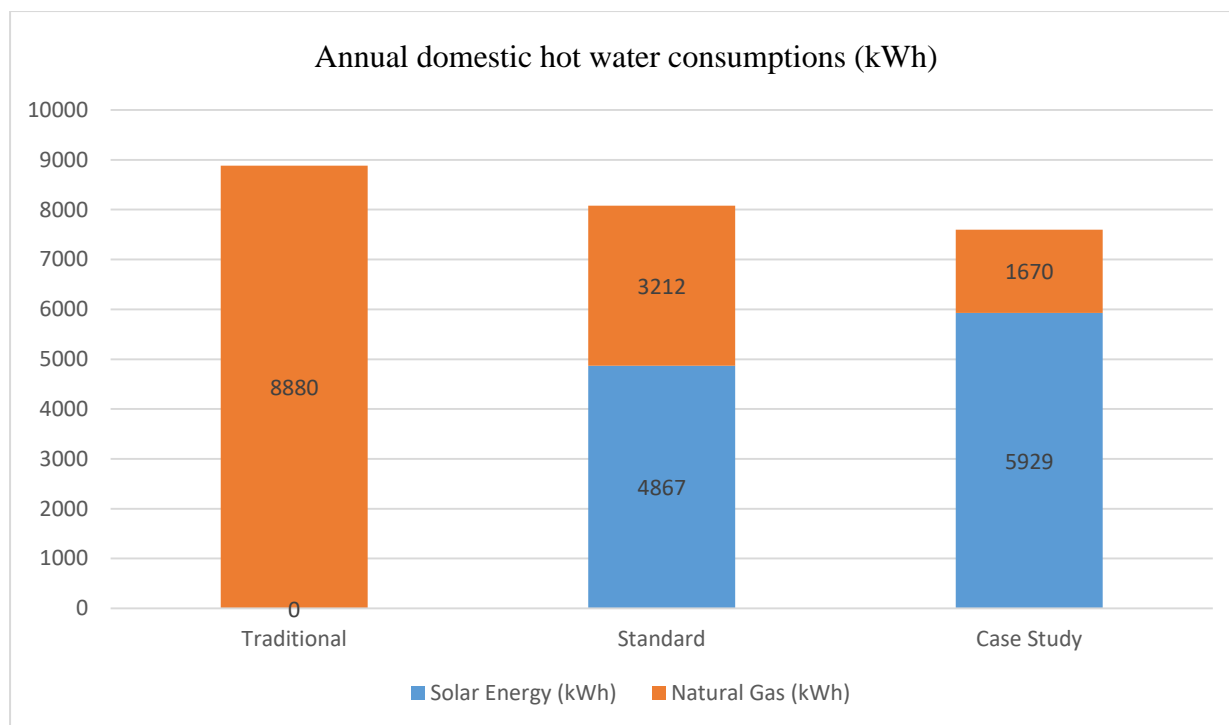
As seen in figure 5, the case study building consumes 81% less natural gas for water heating than the traditional building, and 48% less than the standard building. These values are justified by the renewable energy component, shown in figure 5, and by the efficiency of the installed equipment.

Figure 5: Comparison of Annual Natural Gas Consumption for Water Heating, Considering the use of Solar Energy of the Case Study

The figures presented for the heating and DHW emissions correspond to the consumption in kWh shown in figures 4 and 5 for each of the annual natural gas consumption of the boiler, multiplied by a factor of 0.202 kgCO₂ / kWh, according to the provisions of Portuguese Law (DGEG, 2013).

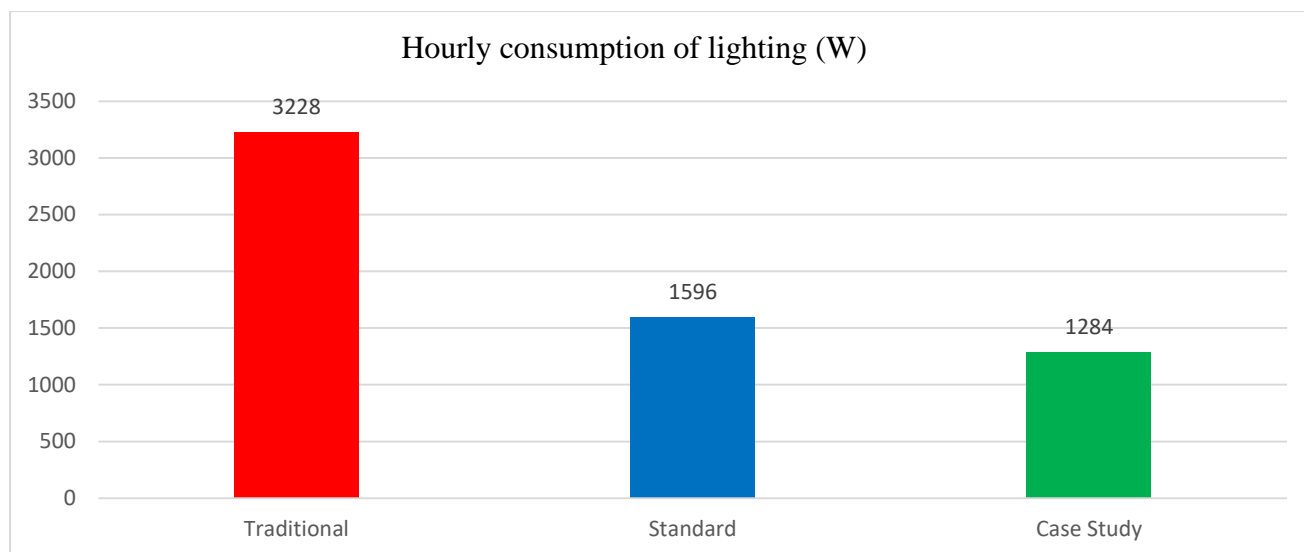
As seen in Figure 6, in what concerns interior lighting the case study building consumes 60% less electricity than the traditional building, and 20% less than the standard building. These values are justified by the use of LED lamps, according to a study of lighting technology undertaken during the design phase.

Figure 6: *Hourly Consumption for Lighting of the Case Study*

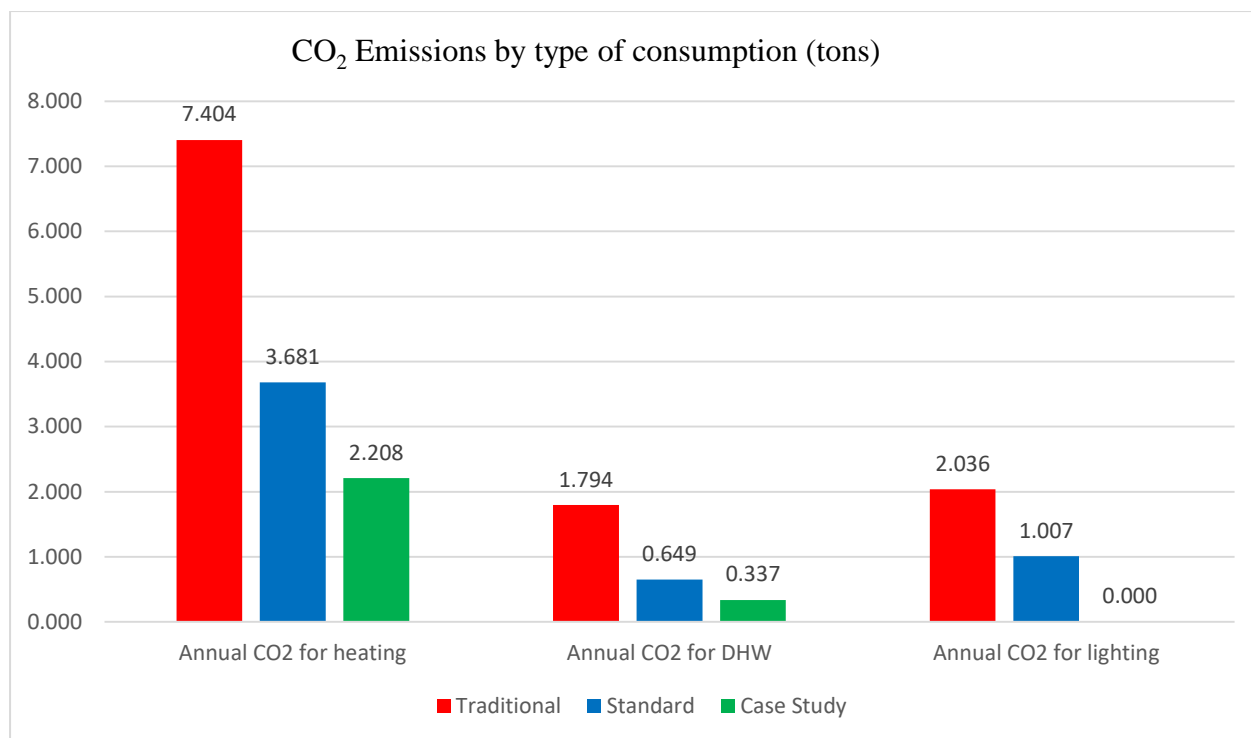
Reducing energy consumption means reducing CO₂ emissions into the atmosphere. Annual CO₂ emissions for heating, domestic hot water and lighting are shown in figure 7, for the three comparison situations.

CO₂ emissions presented for the traditional and standard simulations of lighting consumption, due to the fact that lamps are powered by electricity, are multiplied by a factor of 0.144 kgCO₂ / kWh, according to the provisions of Portuguese Law (DGEG, 2013). Since lighting consumption unit is per hour, calculations were made for an average daily consumption of 12 hours of lighting during the year.

Figure 7: Comparison of Annual CO₂ for Heating

It can be seen, in figure 7, that annual CO₂ emissions for lighting are equal to zero in the case study calculation. This is due to the fact that photovoltaic solar panels provide electricity for interior lighting in a percentage of 100% during the year, resulting that, for this type of consumption, there are no CO₂ emissions.

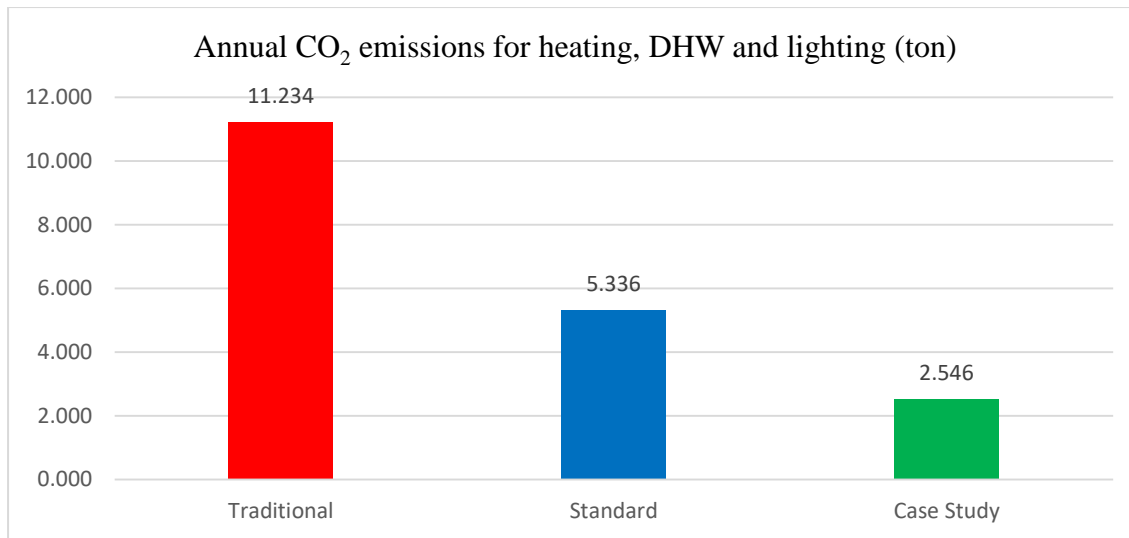
Finally, total results of CO₂ emissions for heating, domestic hot water and lighting are presented in Figure 8 for the three examples.

Comparing the results for the three combined consumption situations, our case study building emits 77% less CO₂ than the traditional building and 52% less than the standard building, which contributes to the sustainability value of the mode of rehabilitation presented in this study.

Figure 8: Comparison of Annual CO₂ Total Emissions
