Paglietti et al., 2024

Volume 10, pp. 27-39

## **CASALE MONFERRATO REMEDIATION: ASBESTOS POLLUTION AND SAFETY MEASURES TO PROTECT WORKERS AND ENVIRONMENT**

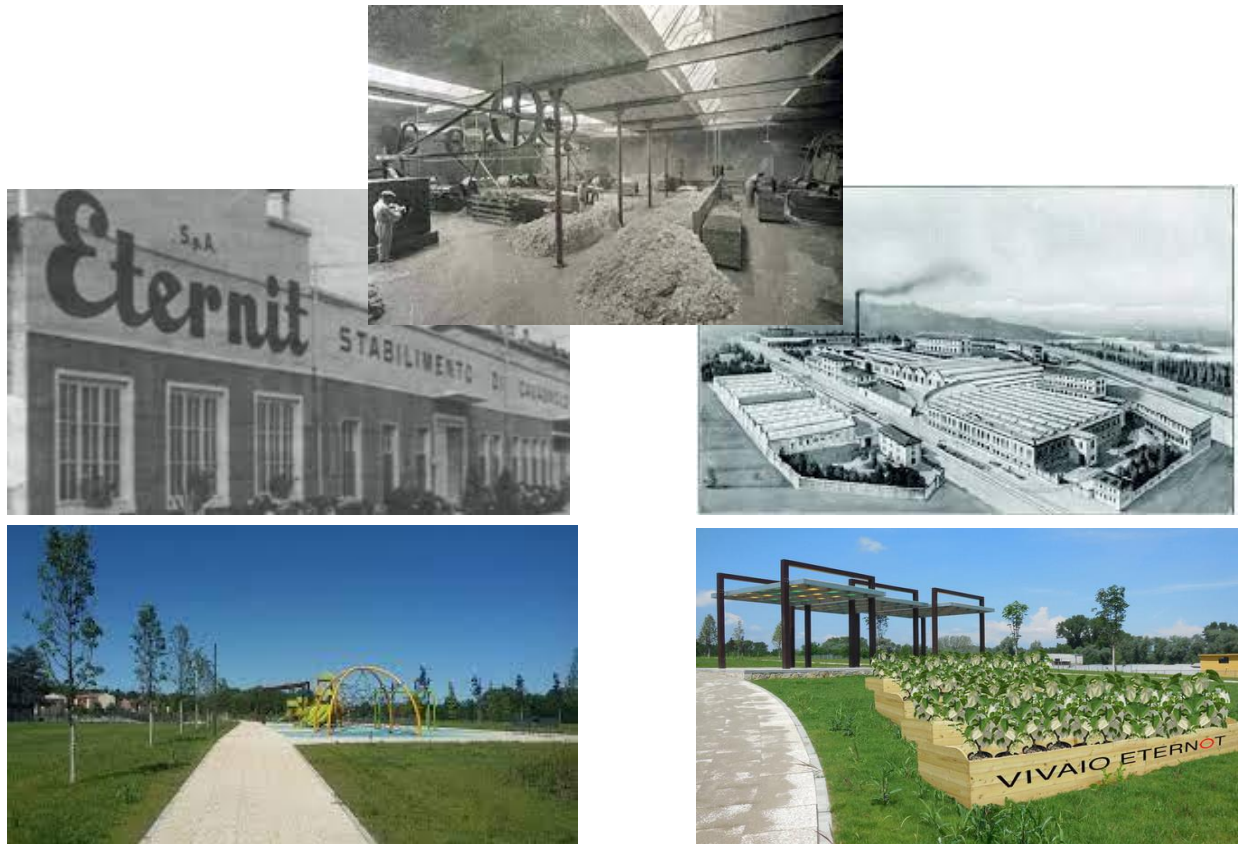
**Figure 1:** *Eternit Factory in Casale Monferrato before and Later Remediation*

The remediation activities that involved both the Eternit and Fibronit plants and the surrounding areas, as well as various municipalities in the district, resulted in the remediation of a large part of the area. Specifically, the following asbestos-related materials were removed from the former industrial plants:

- Approximately 1,500 cubic meters of friable asbestos piles within the plants.
- 54,000 square meters of asbestos-cement roof, including 15,000 cubic meters of sheets that were disposed of in underground production and decantation basins, later buried and secured.

- 160,000 square meters of demolished surfaces.
- 12,000 cubic meters of friable asbestos from the right bank of the Po River, where an actual "asbestos beach" had formed due to the discharge channel of water from the nearby former industrial plants.
- 700,000 square meters of asbestos-cement roof coverings in public and private buildings.
