Wardani Puruhita et.al, 2025

Volume 11, pp. 55-74

## **COMPOSITION AND CHARACTERISTICS OF BRICK FOR CONSERVATION AND RESTORATION MATERIALS OF HERITAGE BUILDINGS AS AN INSPIRATION FOR SUSTAINABLE CONSTRUCTION**

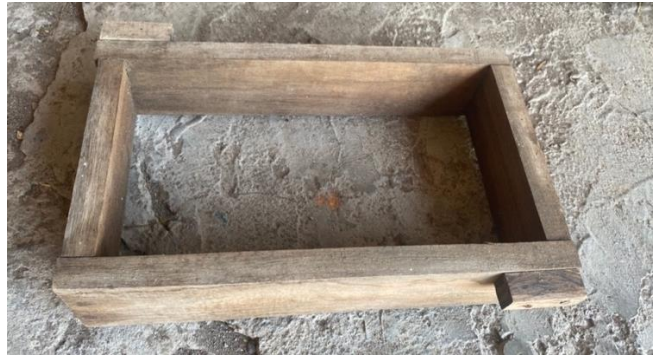
**Figure 1:** Wooden mold measuring 5.5 x 14 x 25.5 cm

- a. Raw materials:
  - 1) Pure clay (fine, not mixed with sand, gravel, or organic materials), taken from several different regions.
  - 2) Clean water
- b. Material Processing
  - 1) Soak the clay in clean water for several days, around 2-7 days, to make it plastic and easy to shape.
  - 2) Knead the clay (tread on it) until there are no lumps.
  - 3) Ensure the clay is homogeneous.
- c. Molding the Materials
  - 1) Make a wooden mold measuring 5.5 x 14 x 25.5 cm.

- 2) The size of the wooden brick mold can be adjusted according to needs.
- 3) Pouring the processed clay into the wooden mold.
- d. Drying the Material

The dimensions of the repair bricks vary, but there are 1 brick whose dimensions match the wooden mold, which is 5.5 x 14 x 25.5 cm, namely brick number 7. All surfaces are flat, 90° angles, and sharp corners. Repair bricks have different colors. In the tested bricks, 100% intake meets the visible properties test according to SNI 15-2094-2000. The results of the bricks size test do not meet SNI 15-2094-2000, due to differences in size/dimensions in heritage bricks and there is a shrinkage value seeing the age of heritage bricks. Brick number 7 is a brick made from clay in the Jaten Karanganyar area with clay conditions that have been left for a long time, namely more than 1 year. Making repair bricks with the same material specifications as number 7 does not require additional dimensions to the mold, because there is no shrinkage in size in the resulting repair bricks.

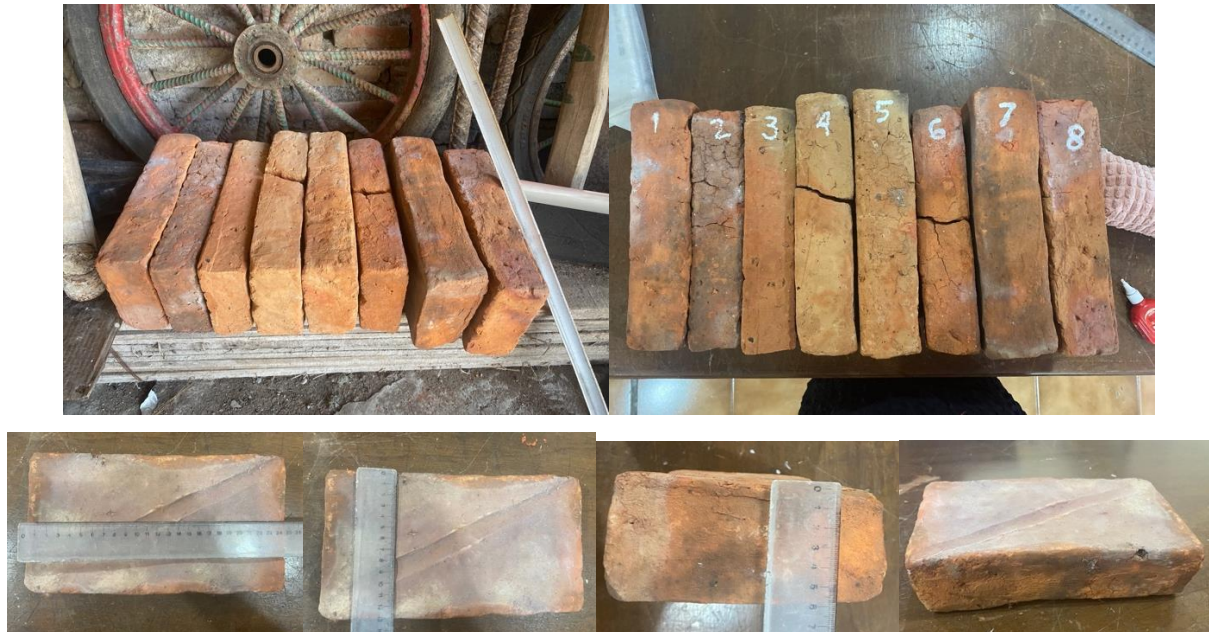
**Figure 2:** *Repair bricks Production Results*

b. Results of bricks from different locations/regions

Based on the visible test results, it can be concluded that from the test of the characteristics of repair bricks in terms of physical properties, all repair bricks are rectangular cube-shaped, with different dimensions even though the materials are in the same region or from different regions.

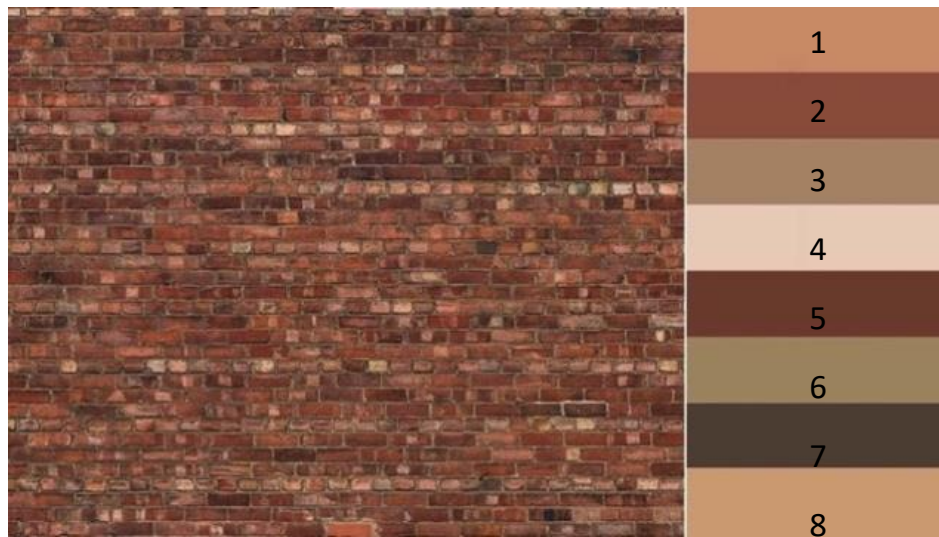
**Figure 3:** Color numbering on bricks material

**Table 3.1** Results of Physical Characteristics Test of Repair bricks Samples
